U.S. Department
of Transportation
**Federal Aviation
Administration**

General Aviation Airworthiness Alerts

AC No. 43-16

**ALERT NO. 236
MARCH 1998**

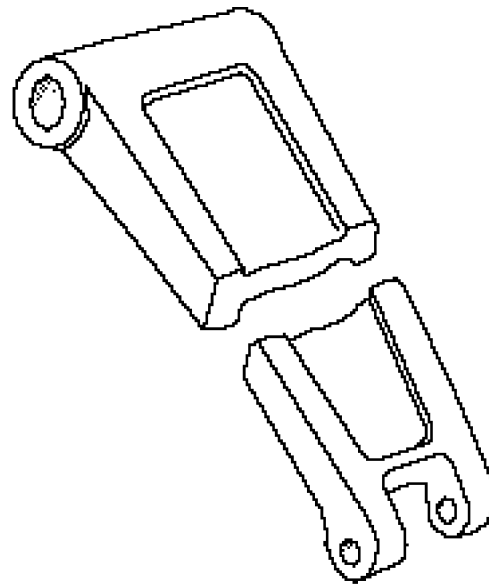
The submitter inspected the aircraft and discovered a broken upper torque link (P/N 1243426-2). The break occurred between the attachment bolt holes. (Refer to the following illustration.) In the past, the submitter found cracks in the upper torque link; however, this is the first time the submitter has seen a crack cause a complete failure of the upper torque link.

If this failure occurred during flight, it could have caused loss of the lower strut or jammed the gear in the nose wheel during retraction.

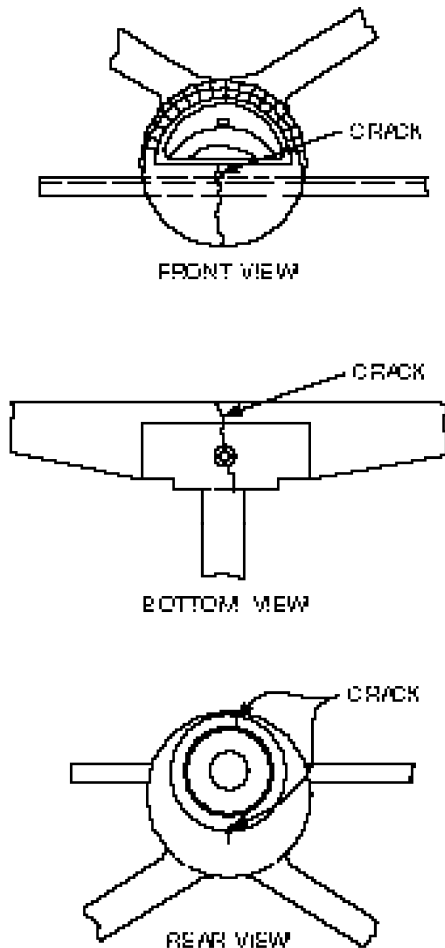
During routine maintenance, the submitter removed the flight control yokes and found cracks on both yokes.

The cracks ran from the attachment pin to the back of the control yoke. The submitter stated that the location of the cracks is similar to those described and pictured in Airworthiness Directive (AD) 64-06-06 and in Piper Service Letter (SL) 369. (Refer to the following illustration.) AD 64-06-06 and SL 369 are not applicable to this aircraft. The submitter suggested that the FAA issue an AD to include all aircraft susceptible to cracks in the flight control yoke.

The occurrence of this type of defect has been published many times. If this defect occurs during a critical phase of flight, the result could be catastrophic. If the yoke is constructed of plastic, the technician should

inspect the assembly for signs of crazing, chipping, cracking, or any other defect which may lead to failure.
